**(03-044) - Detection of anomalies in stainless steel containers by means of infrared thermography**

Royo Pastor, Rafael <sup>1</sup>; Cañada Soriano, Mar <sup>1</sup>; Vivancos, José Luis <sup>1</sup>; Aparicio-Fernández, Carolina <sup>1</sup>; Torner, Maria Eugenia <sup>1</sup>

<sup>1</sup> Universitat Politècnica de València

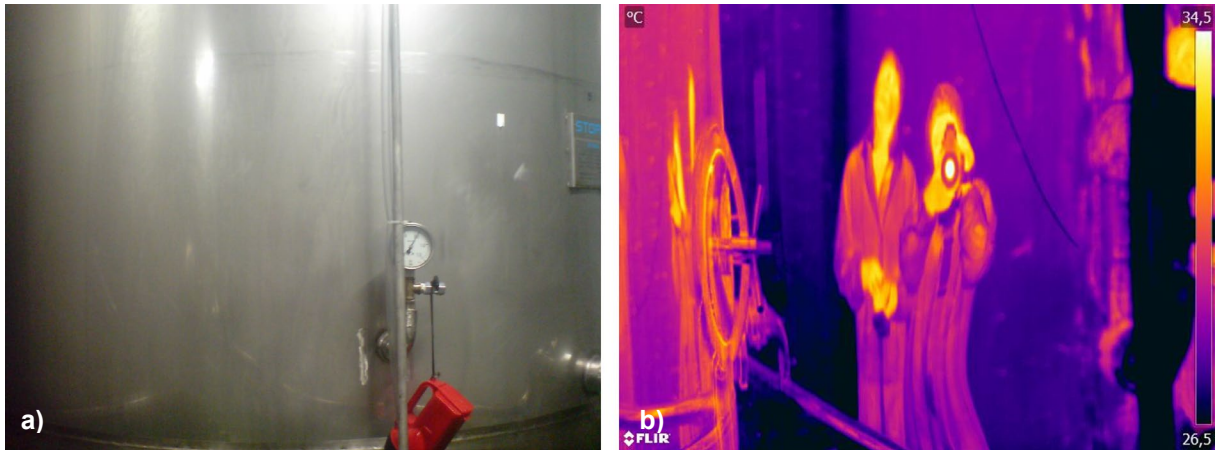
where  $\varepsilon$  is the emissivity of the object,  $\sigma$  is the Stefan-Boltzmann constant,  $T_{\text{obj}}$  [K] is the temperature of the body surface and  $T_{\text{surr}}$  [K] is the temperature of the surrounding surfaces. Hence, body surfaces with lower emissivity present higher values of reflectivity, which would lead to greater surroundings' influence. For this reason, thermal reflections play an important role when it comes to detect flaws based exclusively on thermal patterns. In this sense, the materials themselves, or their surface's characteristics such as the geometry or the surface finishing have a direct influence. Specifically, smooth surfaces such as glass, polished and/or varnished metals or wood are the ones that makes infrared inspections most challenging since they lead to specular reflections. In these situations, the reflections of objects around the element being inspected along with even the thermographers themselves may predominate over the thermal patterns associated with the inspected element itself. Figure 2 shows an example of such behaviour where the thermographers' reflections on a metal tank can be observed on the infrared image (Figure 2b).

**Figure 2: Thermal reflections observed on an infrared image on a tank made of metal.**

Thus, when performing qualitative thermography to detect specific thermal patterns associated to defects or failures, it is advisable avoiding thermal reflections.

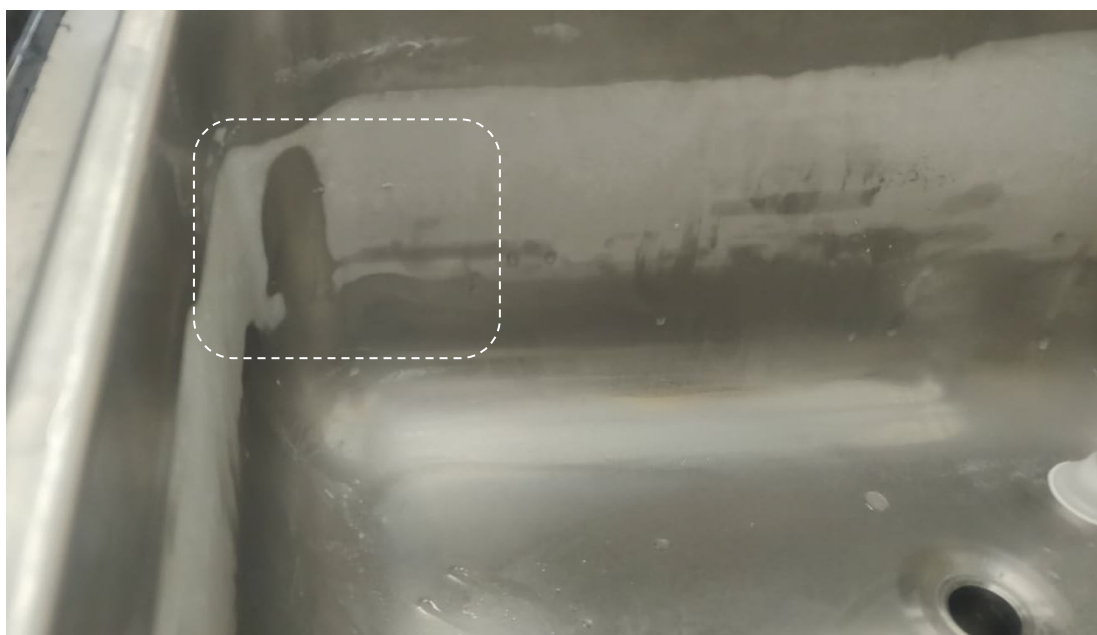
The reference container presenting the correct welding was the first one to be inspected. Then, ten containers suspected of presenting welding faults were analysed. In such cases, the manufacturer noticed that during the normal operation, in which cold gas is injected through the coil, the cooling inside the containers were uneven. Figure 7 shows an example of this situation. Certain areas of the inner surface present non-uniform cooling, which may mean a failure in the welding of the coil.

**Figure 7: Stainless steel container in normal operation for storing ice-cream. Certain zones presenting uneven cooling can be observed.**

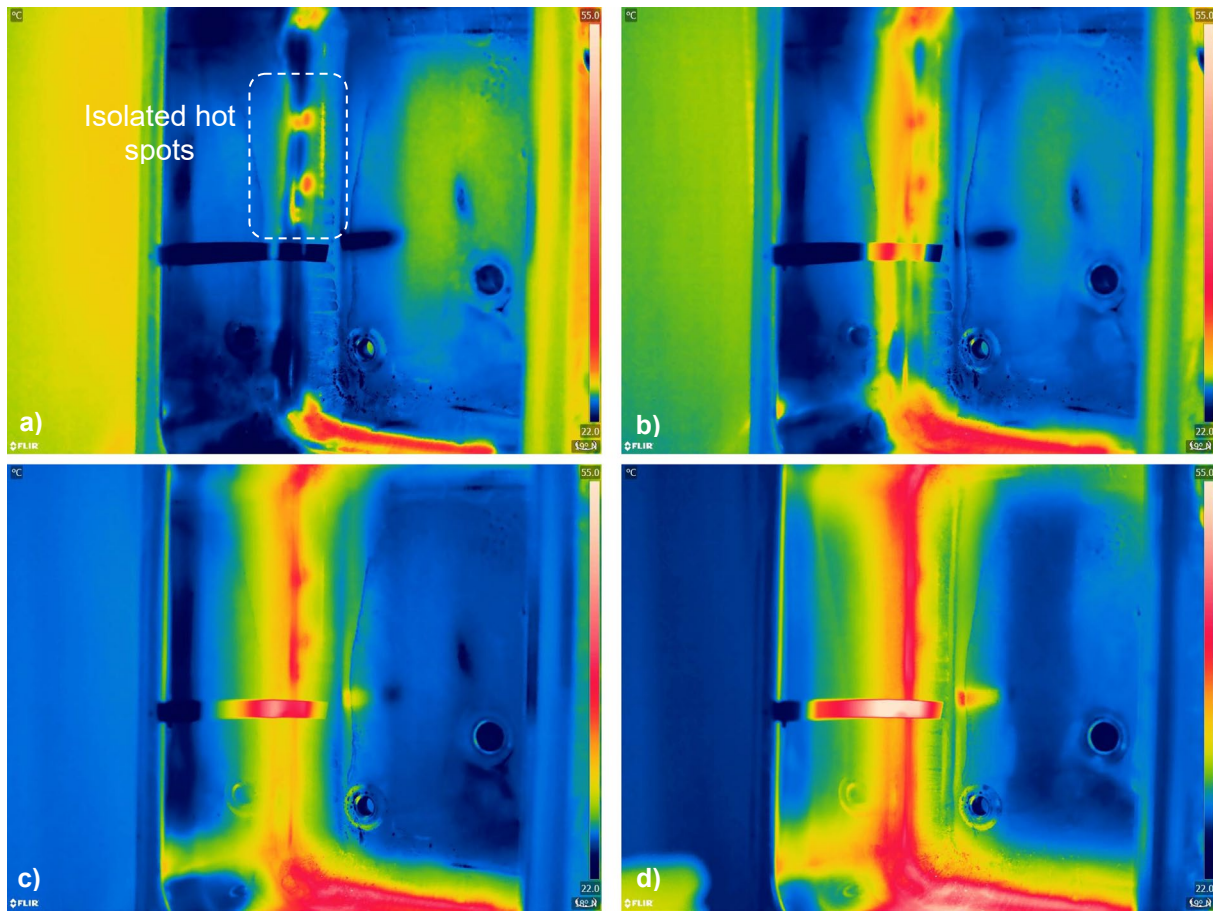
Following the reference container, ten more containers suspected of presenting welding faults were analysed. Among them, a lack of uniformity in thermal patterns was detected in some cases. Figure 9 shows an example of a stainless-steel container with an uneven thermal response. In Figure 9a, already after the coil starts to be heated up, isolated hot spots appear in the inner surface instead of a continuous heating line corresponding to the first circuit tube. Besides, the adjacent inner surface corresponding to the narrowest one of the container already presents a more pronounced warming. About one minute after (Figure 9c), although the inner surface present a warm-up, it lacks uniformity.

**Figure 9: Infrared images of a stainless-steel container taken after the hot gas is injected into the coil. After: a) 30 s b) 60 s, c) 90 s and d) 120 s.**

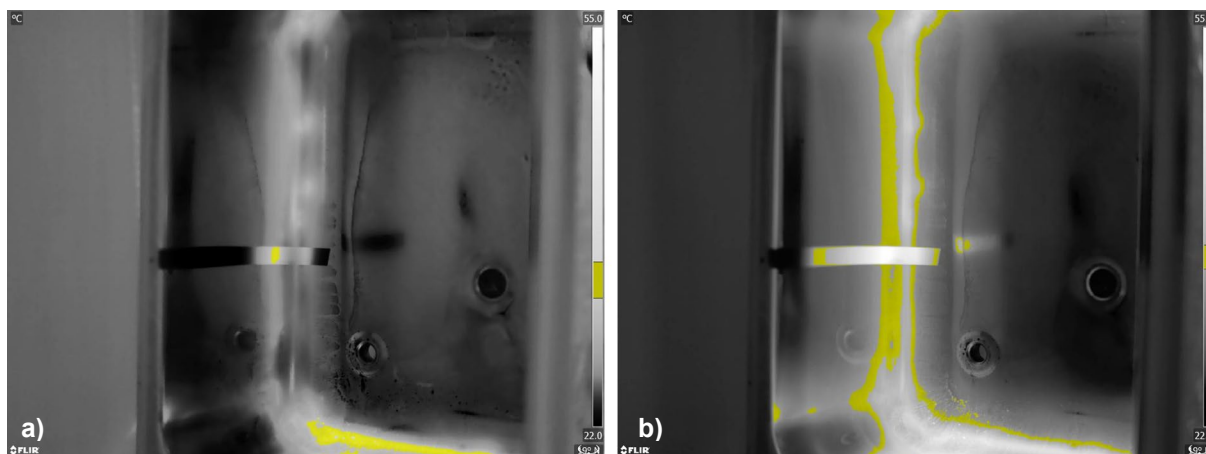
Using the same infrared images on Figure 9, a complementary support tool has been applied in order to make it easier to detect the contact problems on the container (Figure 10). The mentioned tool, known as isotherm, highlights the desired temperatures interval within the infrared image. Thus, the original infrared image is displayed in gray palette and the isotherm, conversely in yellow, highlights only the areas within the image in the selected apparent temperatures. In Figure 10a) and b), specifically, the isotherms indicates the temperature intervals from 32.6 °C to 35.6 °C and from 35 °C to 37 °C, respectively. In this sense, it can be clearly seen that the heating up pace is irregular in the two different inner surfaces evaluated in the thermography inspection. On the one hand, as previously mentioned, the inner surface where the electrical plate is placed, presents a slower warming. When apparent temperatures reach 36 °C, the adjacent surface has already overcome 45 °C (Figure 10b). Moreover, warming on this surface is far from being uniform since, as it can be observed, there is an area comprised in the middle of the isotherm at a higher apparent temperature. Similarly, will occur when instead of hot gas, a cold gas would be injected through the coil in normal operation. As a result, there will be areas of the inner surface presenting irregular thermal patterns, and consequently, cooling the stored ice-cream in an irregular way.

**Figure 10: Isotherm used on infrared images of a stainless-steel container taken a) one and b) 2 minutes after the hot gas is injected into the coil.**

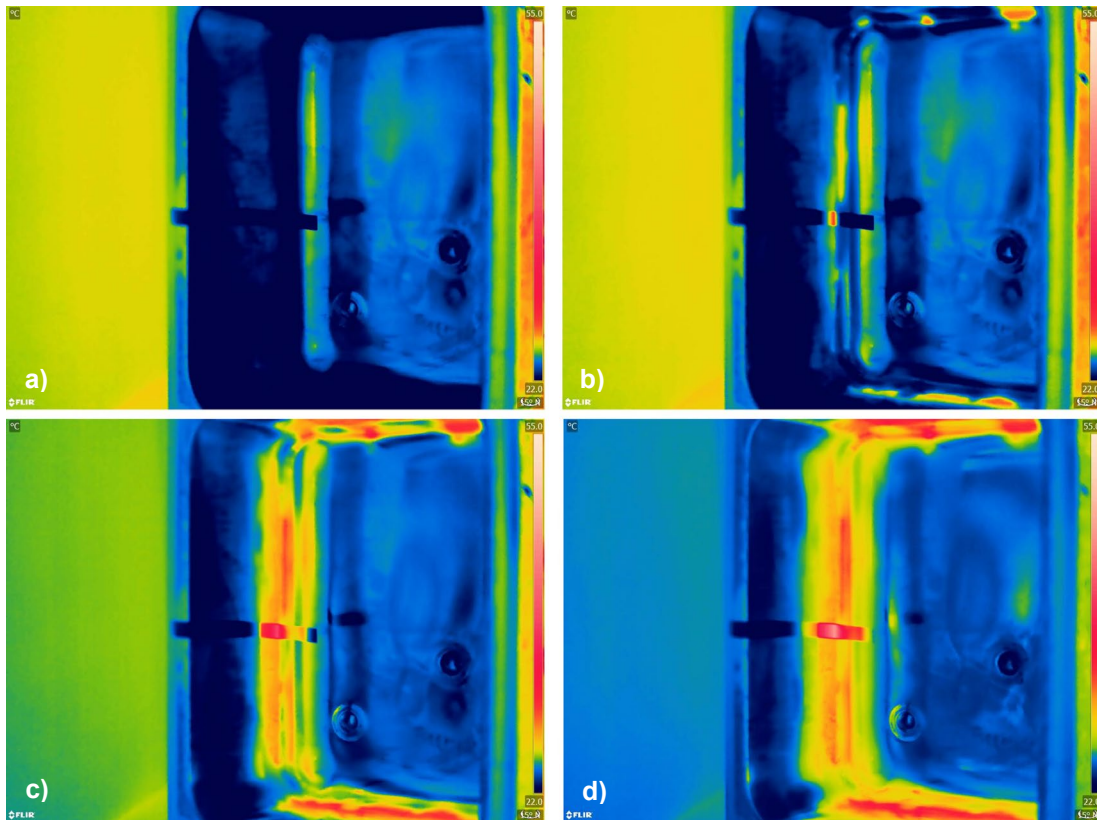
Figure 11 shows another example of a stainless-steel container with an uneven thermal response, in which infrared images acquired right after the injection of the hot gas into the coil and after 30, 60 and 90 seconds are presented. In this case, the inner surface corresponding to the one where the electric tape is placed shows at first a warming in form of a line, instead of spots. Nevertheless, subsequent infrared images reveal the irregular warming on the different surfaces of the container. Thus, in Figure 11 c) areas located near the corners present lack of warming, whereas central areas show better uniform heating. This latter effect seems reasonable since the welding of the coil at the corners would be more difficult. Therefore, the areas observed on the corners could correspond to poor contact areas due to welding failures.

**Figure 11: Infrared images of a stainless-steel container taken a) right after the hot gas is injected into the coil and after: b) 30 s c) 60 s and d) 90 s.**
