**(03-044) - Detection of anomalies in stainless steel containers by means of infrared thermography**

Royo Pastor, Rafael <sup>1</sup>; Cañada Soriano, Mar <sup>1</sup>; Vivancos, José Luis <sup>1</sup>; Aparicio-Fernández, Carolina <sup>1</sup>; Torner, Maria Eugenia <sup>1</sup>

<sup>1</sup> Universitat Politècnica de València

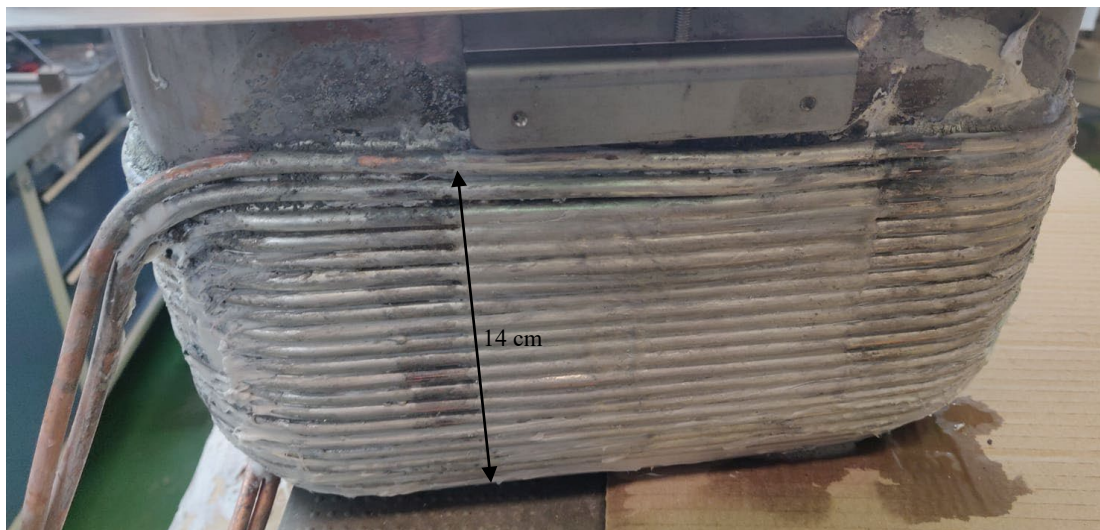
**Figure 3: Outer surface of a container showing the welded coil**

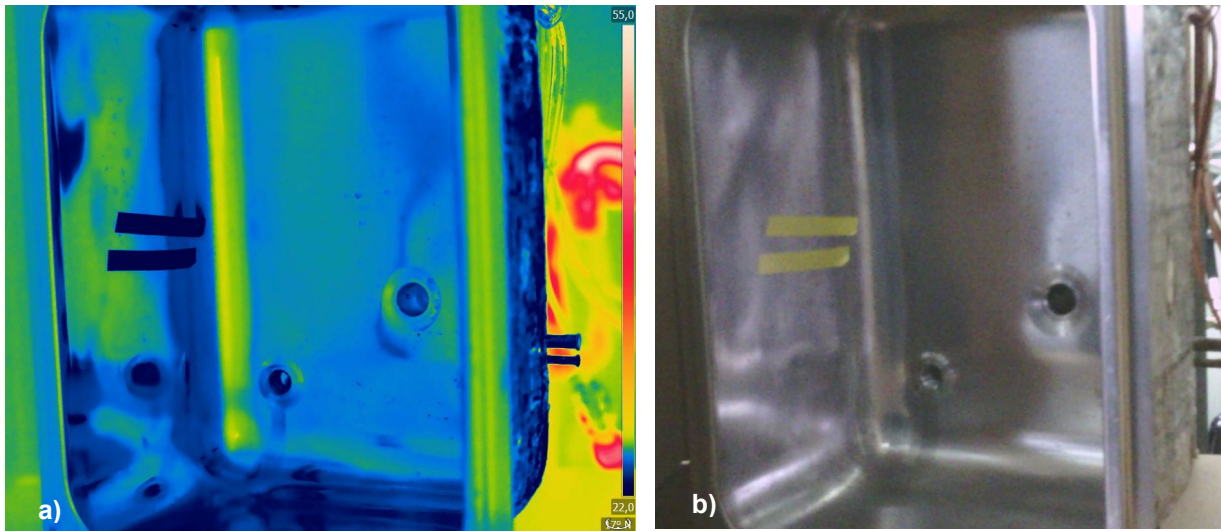
**Figure 6: a) Infrared and b) visual image of the inner surface of a stainless-steel container at ambient temperature.**

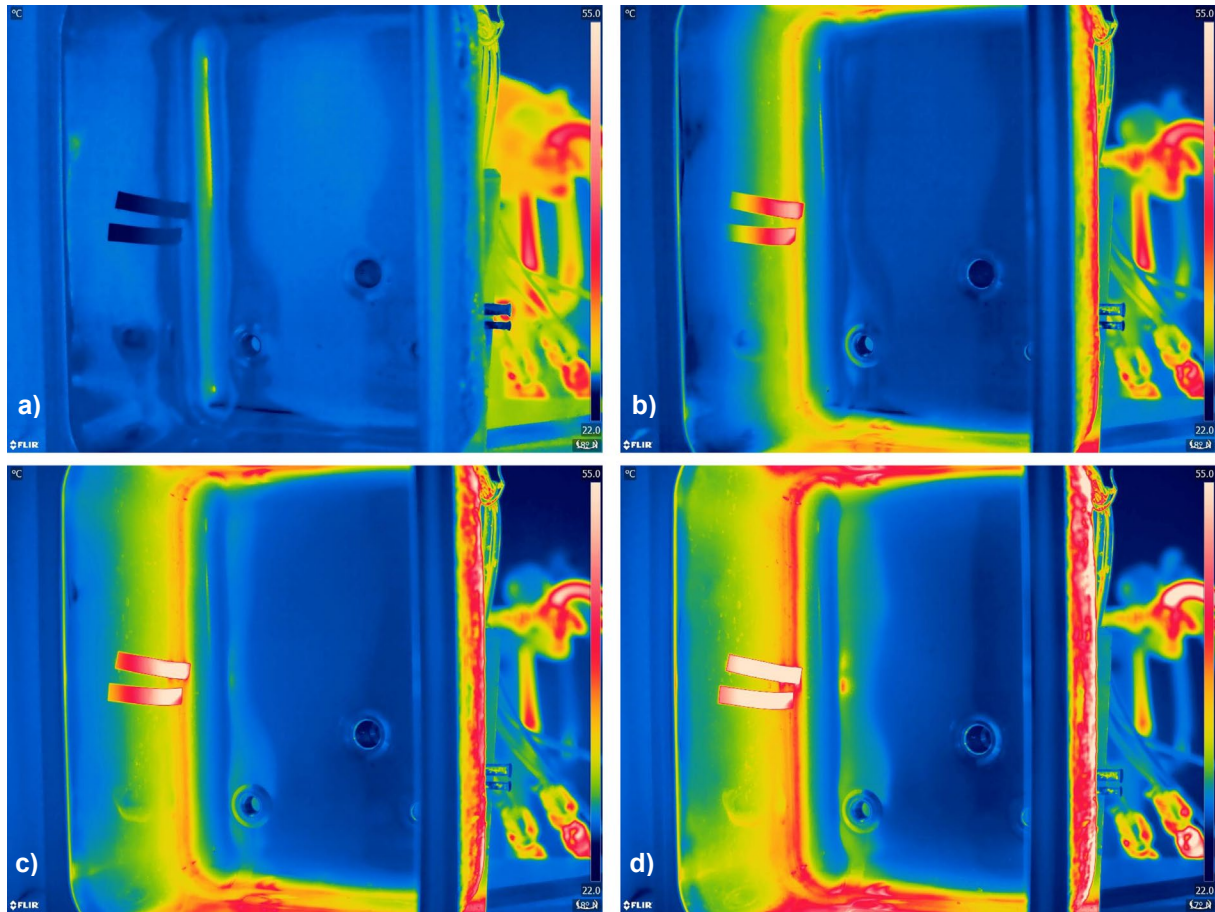
To have a baseline of proper operation, a container with its coil assumed to be correctly welded and with proper thermal contact was first inspected. As can be observed in Figure 8, from the first moment when the hot gas is injected through the coil (Figure 8a), and until 90 seconds after (Figure 8d), the thermal pattern corresponding to the heating of the coil is uniform. Additionally, the thermal pattern observed within the tapes placed on the inner surface, confirm such uniform warming. Hence it may confirm the appropriate thermal contact between the coil and the container and, therefore a correct welding.

**Figure 8: Infrared images of the reference stainless steel container taken every 30 seconds right after the hot gas is injected into the coil (a).**
